AZOVSTAL STEELPLANT MARIUPOL, UKRAINE Property Assessment Report

Update issued by Skytek: at 12:00 GMT on June 08th 2022

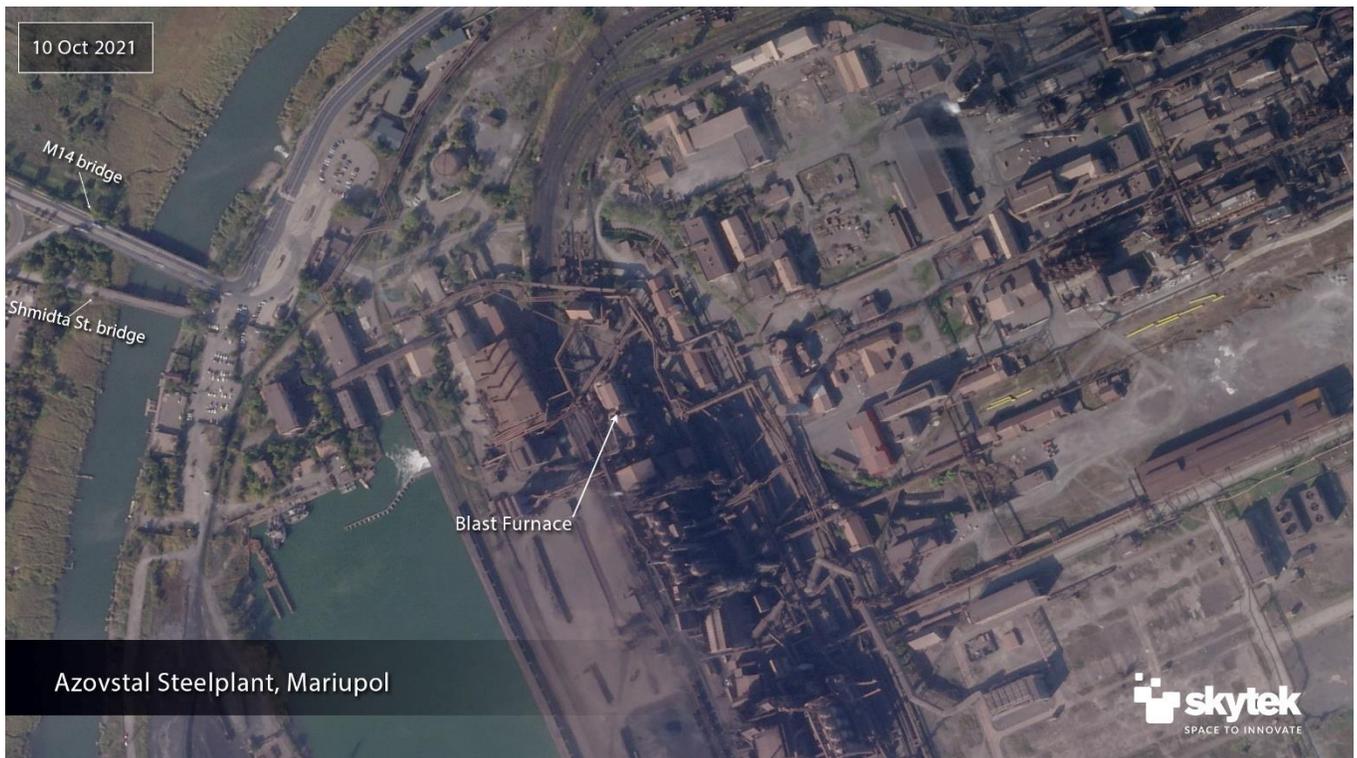
Skytek carried out an analysis of the site of the plant, using very-high resolution imagery dated prior to the Russian attacks. Figure 1 represents a satellite image of the site of the plant dated October 2021. Sytek observes that the steam exhaust on the funnels and water cooling discharges near the furnaces are still in use, indicating the plant is fully functional and in full activity, on October 10th, 2021.

Figure 1 – Azovstal plant on October 10th, 2021, area detail

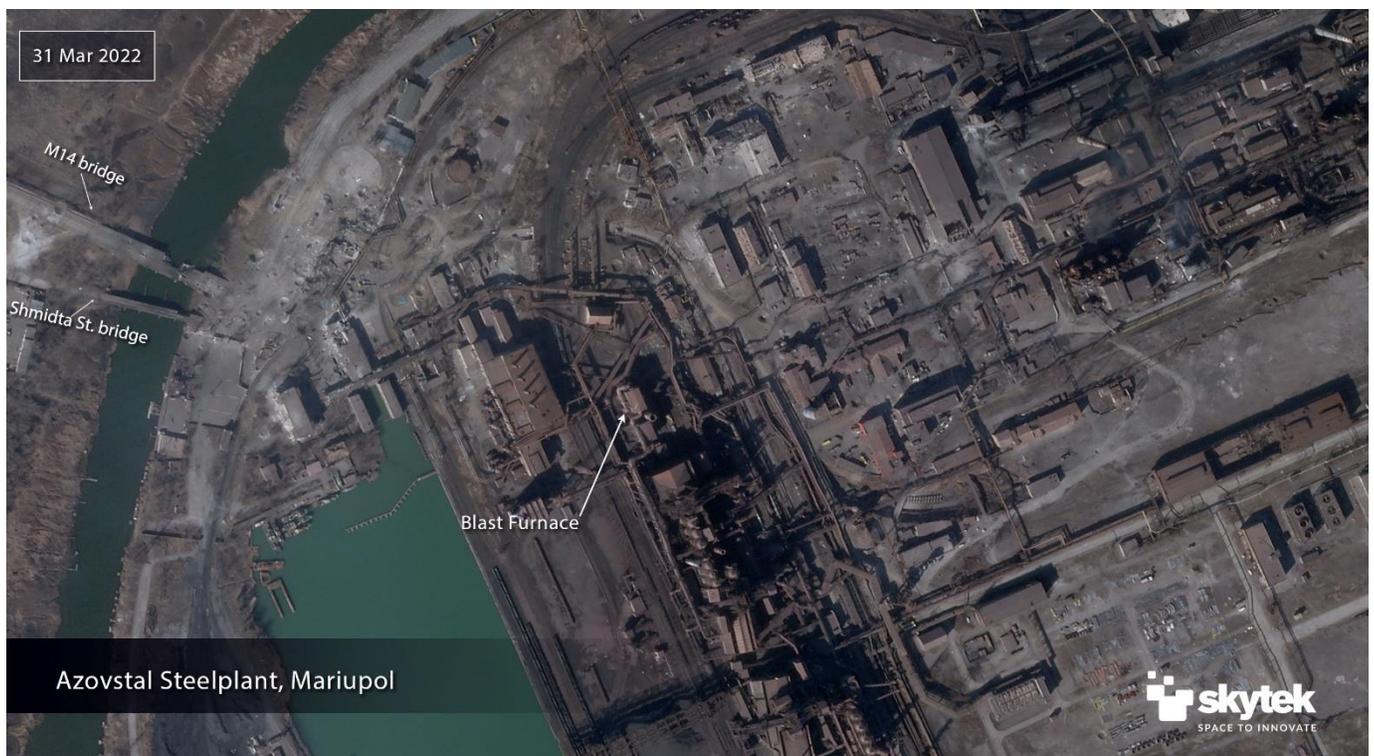
On March 31st, 2022, the Russian troops started bombing heavily the Azovstal plant. Skytek has tasked and acquired very-high resolution satellite imagery to analyse and identify in detail the damage sustained by the infrastructure and generally speaking the surrounding areas. A view of the area with annotated damages as of March 31st, 2022, can be seen in Figure 2.

Figure 2 – Azovstal steel plant on March 31st, 2022, area detail

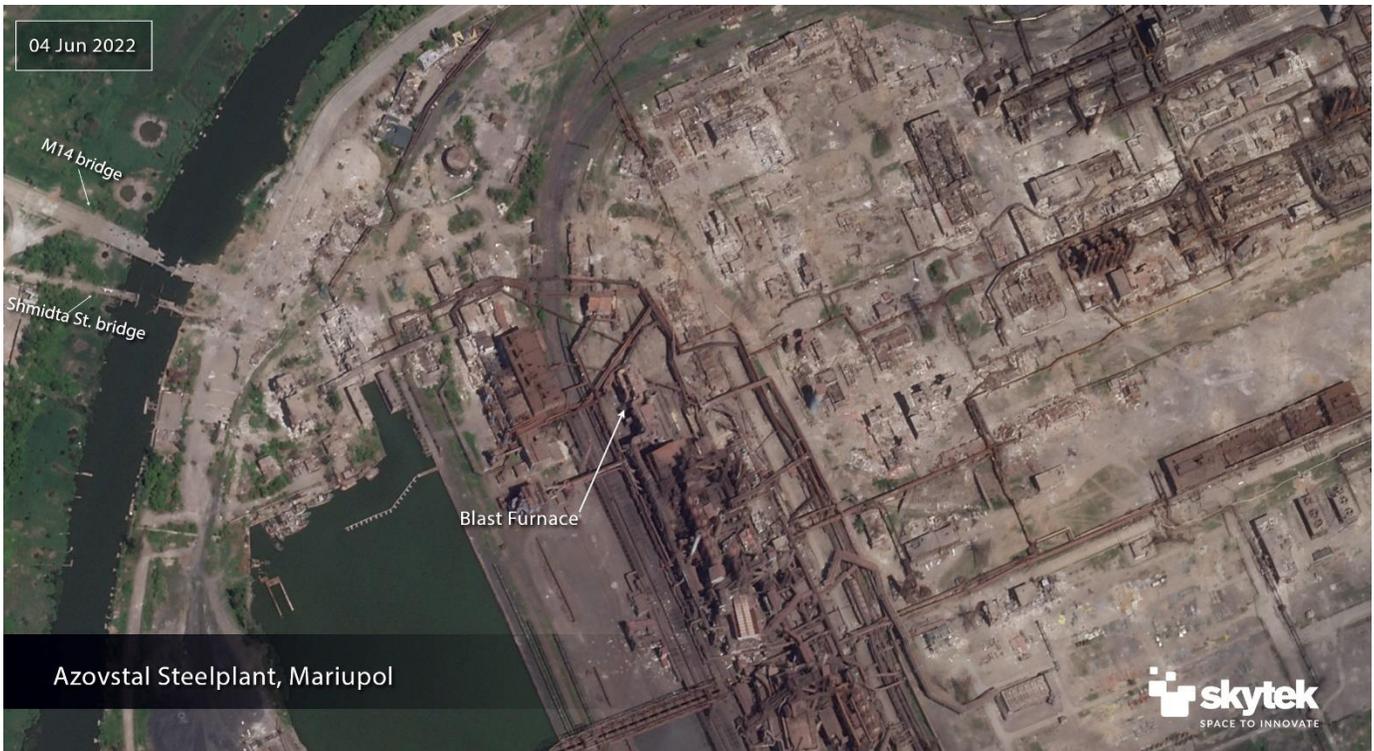
Skytek's analysis of the remainings of the steel plant from this image, is provided within the annotations. The two bridges providing access to the plant appear completely destroyed, and nearly everything on the 11 square km area that the plant occupies, appears to be hit by a bomb and shattered to the ground.

Figure 3 – Azovstal steel plant on June 04th , 2022, area detail
