# CHUQUICAMATA MINING COMPLEX DAMAGE ANALYSIS

Update issued by Skytek: at 12:00 GMT on October 27<sup>th</sup>, 2022

On August 3<sup>rd</sup>, 2022, an incident occurred at the Chuquicamata concentrator plant, and Skytek was requested to investigate the asset's condition using very high-resolution satellite imagery.

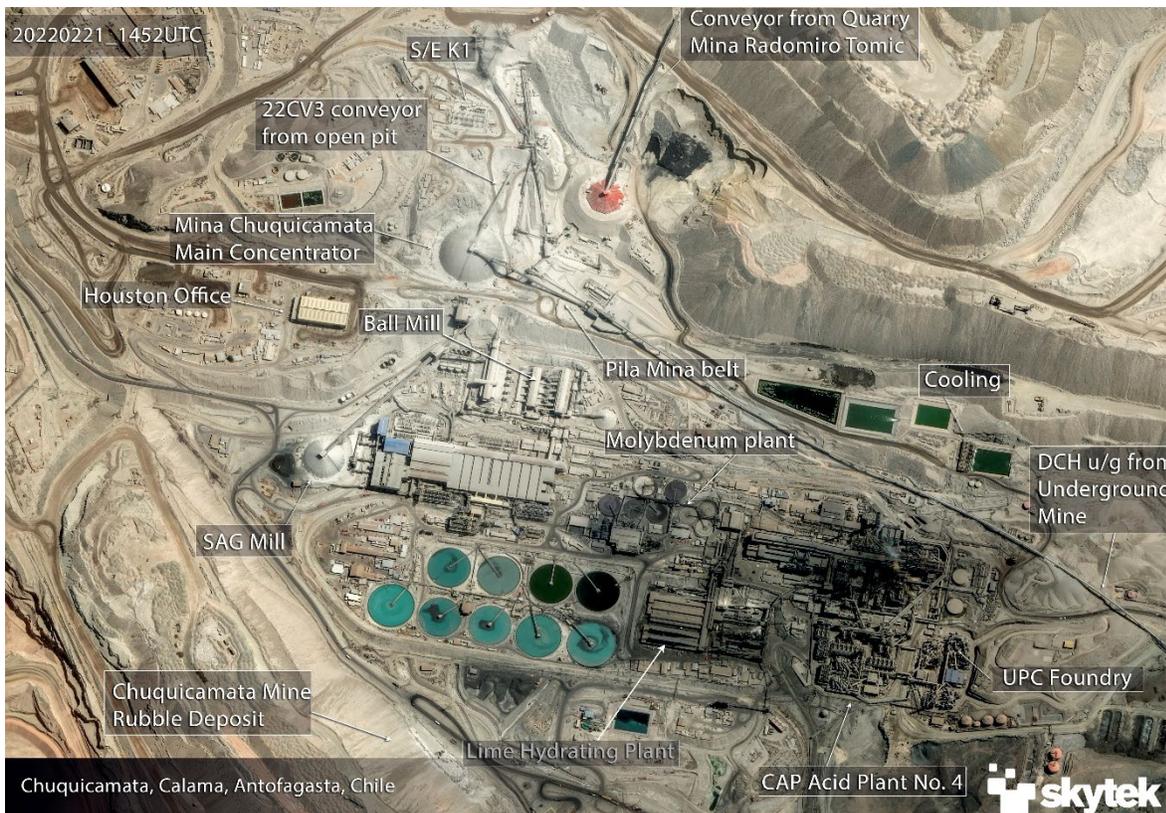
Skytek obtained a very high-resolution image dated February 21<sup>st</sup>, 2022, represented in Figure 1 (overview), depicting the main conveyor belts converging in the Chuquicamata concentrator and the Pile Mineral Treatment Plant (PTMP):

Figure 1: Mineral Treatment Plant (PTMP) and Chuquicamata concentrator, on February 21<sup>st</sup>, 2022 – Overview Credits @AirbusSpace

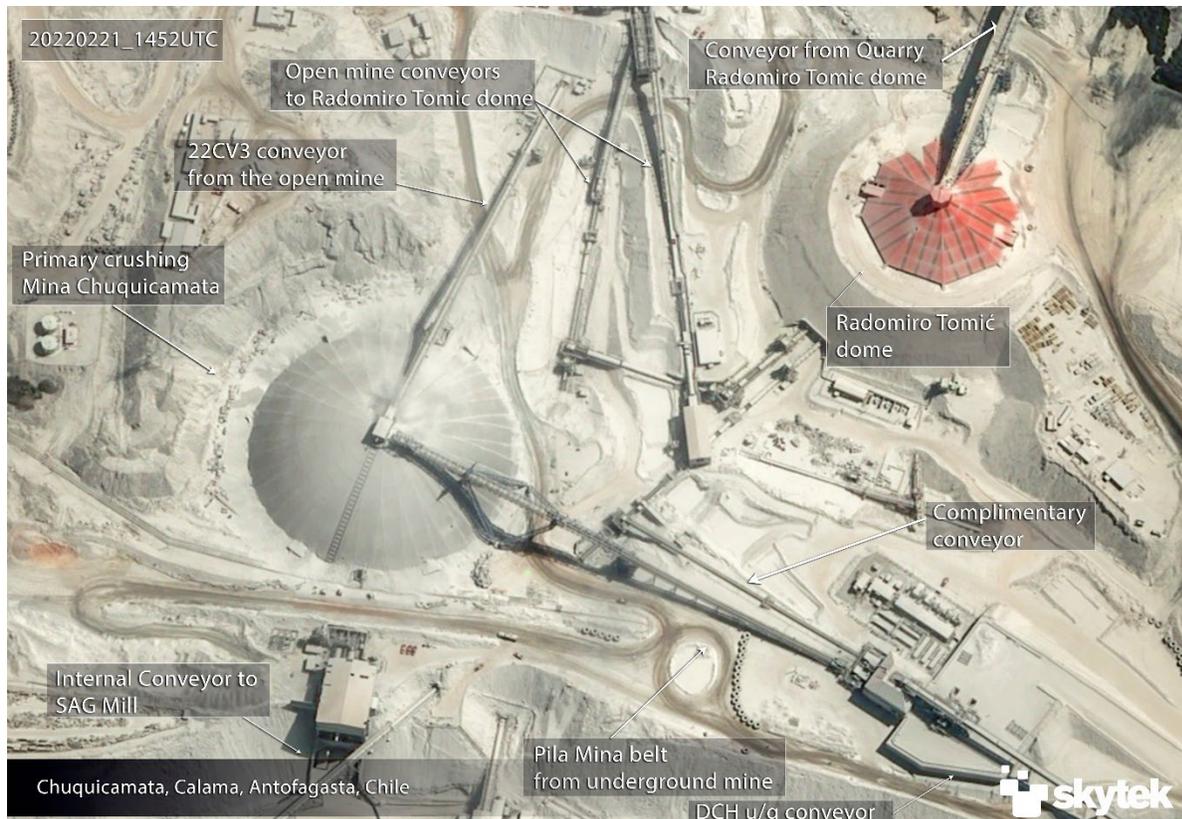
Figure 2: Mineral Treatment Plant (PTMP) and Chuquicamata concentrator on February 21<sup>st</sup>, 2022 – Detail Credits @AirbusSpace

The very high-resolution image acquired on February 21<sup>st</sup>, 2022, in Figure 2 (detail), shows in detail the Chuquicamata concentrator and treatment plant. Analysing this image at 50cm resolution, Skytek makes the following observations:

- The dome of the Chuquicamata concentrator appears in good structural condition
- The dome of the Radomiro Tomic concentrator appears in good structural condition
- The main conveyor belts appear in good structural order and fully functional:
  - o 22CV3 from the Chuquicamata open mine to the main concentrator via the complementary conveyor
  - o the DGH u/g and Pila Mina conveyors from the Chuquicamata underground mine to the main concentrator
  - o the Radomiro Tomic conveyor to the main concentrator via the complementary conveyor
  - o Internal conveyor belts from the Chuquicamata open mine to the Radomiro concentrator to the Chuquicamata concentrator via complementary belt appear in good structural condition

- The Treatment Plant (PTMP), Ball and SAG mills appear in good structural condition

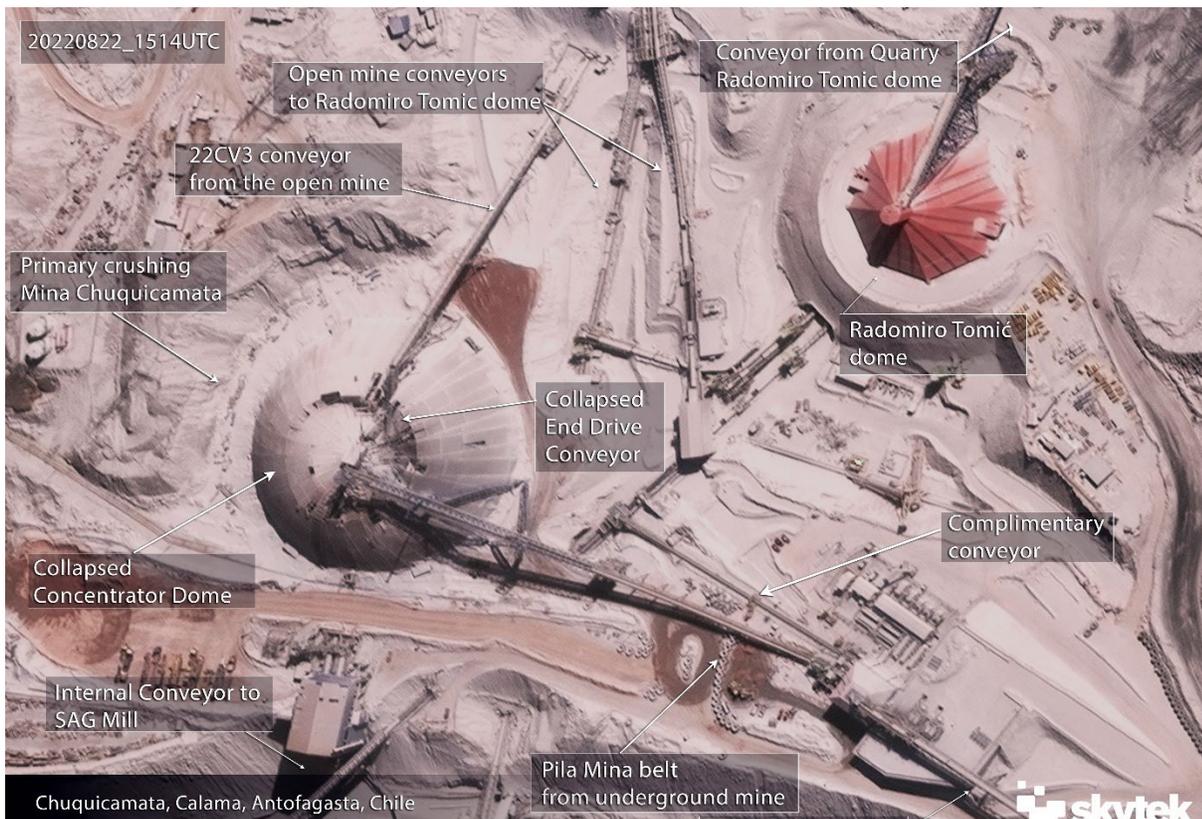
Following the Chuquicamata concentrator incident on August 3<sup>rd</sup>, Skytek obtained a very high-resolution image for the post-event assessment. This image, represented in Figure 3 below, is dated August 22<sup>nd</sup>, 2022, and it is at 40cm resolution.

Figure 3: Chuquicamata copper mine, detail of the Concentrator Dome on August 22<sup>nd</sup>, 2022 @Digital Globe WorldView satellite

- The top of the Chuquicamata concentrator dome appears to have collapsed over the copper concentrate. There are several holes punctured in the walls of the dome, whose structural condition appears compromised
- 22CV3 conveyor from the Chuquicamata open mine to the main concentrator appears to have the end drive collapsed together with the top of the dome he was resting upon

- The dome of the Radomiro Tomic concentrator appears to be in good structural condition
- the DGH u/g and Pila Mina conveyors from the Chuquicamata underground mine to the main concentrator appear in good order. The end drive of the Pila Mina conveyor was not resting on the Chuquicamata concentrator dome and appeared to have sustained minor damage to the head chute at its apex.
- The Radomiro Tomic conveyor to the main concentrator via the complementary conveyor appears in good condition
- The Treatment Plant (PTMP), Ball and SAG mills appear in good condition.

- The East wall of the Chuquicamata concentrator dome appears to have deteriorated significantly further in comparison to the condition reflected on August 22<sup>nd</sup> (see Figure 3 above)

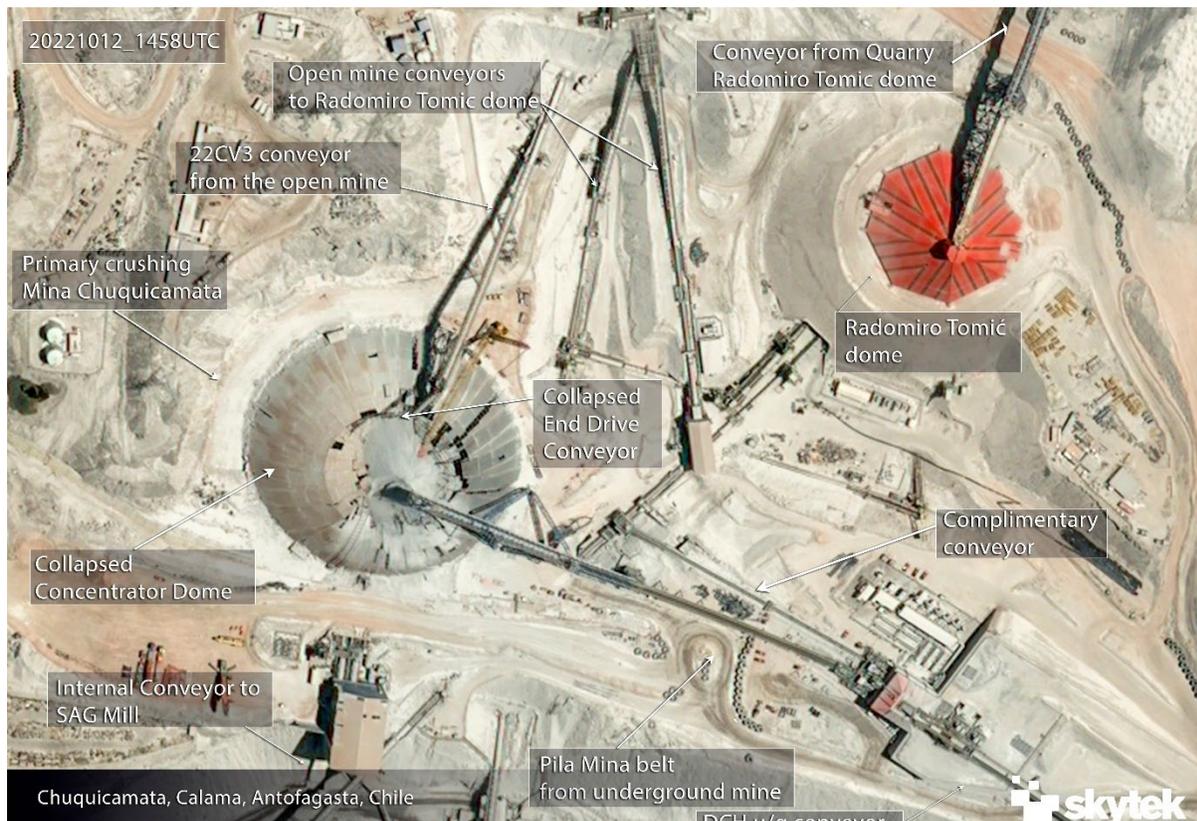
Remedial works were expected to begin shortly after the incident. To assess the progress of these works, Skytek obtained a very high-resolution image dated October 12<sup>th</sup>, 2022, at 50cm resolution, as depicted in Figure 4 below.

Figure 4: Chuquicamata copper mine, detail of the Concentrator Dome on October 12<sup>th</sup>, 2022 Credits @AirbusSpace

- Near the 22CV3 conveyor, a crane has been stationed potentially to assist with the removal of the dome structure
- 22CV3 conveyor from the Chuquicamata open mine to the main concentrator appears in the same condition as on August 22<sup>nd</sup>, with the drive end broken

- The dome of the Radomiro Tomic concentrator appears to be in good structural condition
- the DGH u/g and Pila Mina conveyors from the Chuquicamata underground mine to the main concentrator appear in good order with no significant changes since August 22<sup>nd</sup>

- The Radomiro Tomic conveyor to the main concentrator via the complementary conveyor appears in good condition
- The Treatment Plant (PTMP), Ball and SAG mills appear in good condition.
